HISTORIC STRUCTURE REPORT

THE PARSON CAPEN HOUSE

The Topsfield Historical Society
Topsfield, Massachusetts

APRIL 1 2002

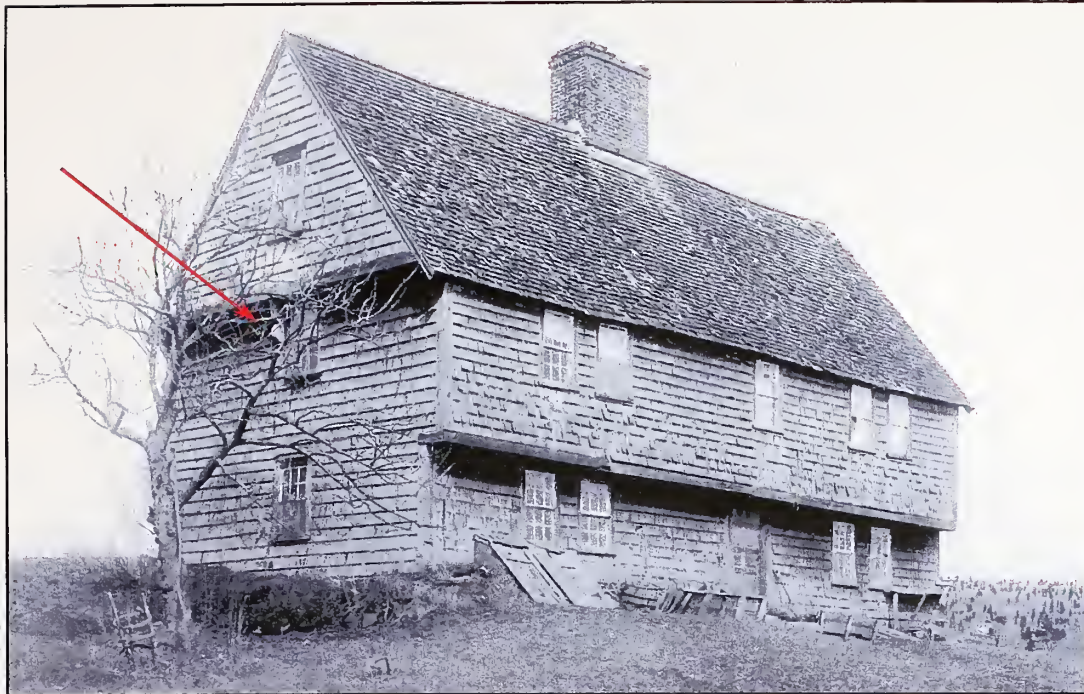
At the west gable the central bracket below the overhanging attic girt is original based on its presence in all the pre-restoration photographs dating back to the 1880's (Fig. 1.1). To verify that the existing bracket is not a replacement, the 1913 photographs were blown up and the visible wood grain and weathering patterns were compared to the current bracket (Fig. 2.1, 2.2). The patterns were the same. The large knot in the end grain of the lower edge of the bracket is the most obvious feature still visible in the current bracket. Although the 1920 Old Time New England (OTNE) article by Donald Millar on the restoration cannot be taken as fully accurate in the absence of other evidence, Millar specifically identifies this bracket as an original feature.

1.1: C. 1880's photo of the house showing the west and south facades. The arrow points to the one surviving original gable bracket which is still present on the west facade. The house was locally known for its venerable history. Its first written documentation was an 1894 newspaper article. The house had been tenanted for well over a hundred years at the time of this photo. The windows have 19th century 6/6 sash in them, but the openings date back to the 18th century.

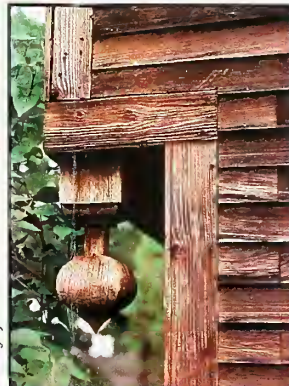
1.3: 1960's photograph showing naturally weathered appearance.

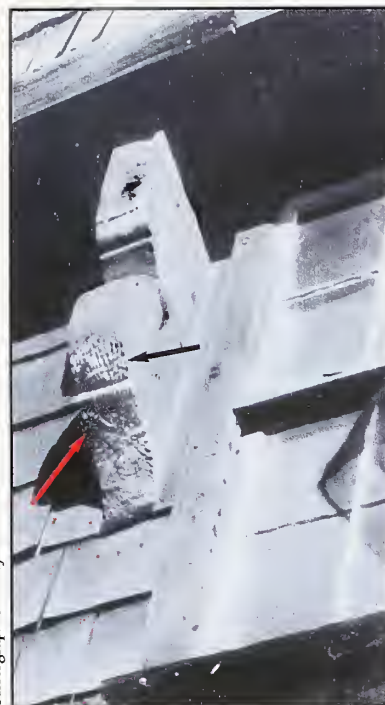
2.2: West gable bracket in place in 1913 construction photo taken before window was removed. Comparison of the grain pattern on this bracket with the existing one verifies they are the same.

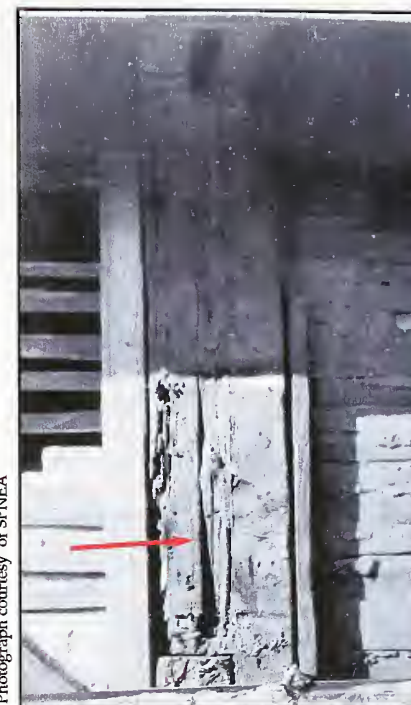
2.4: 1913 photograph at the west front chimney post and girt. The gain cut into the post is visible with the hacked off remains of the bracket tongue still in place. This provided Dow with the height of the bracket.

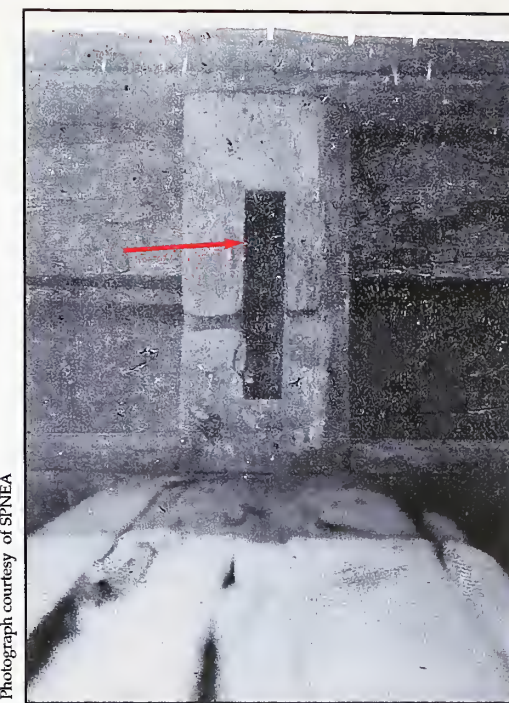
2.5: 1913 photograph looking up at the west front chimney girt. The mortise and pin hole for the bracket tenon are clearly visible, although about an inch of the bottom of the girt is missing. This with the gain in the post is firm evidence for Dow's bracket restoration.

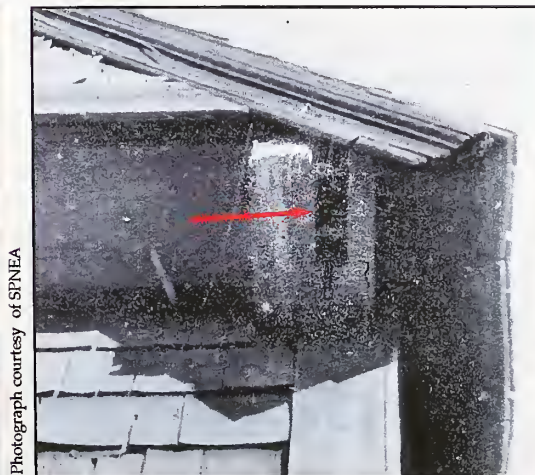
The inner portions of the projecting front and rear plates supporting the end girts are also original. These are shown in the 1913 photographs as extending to the outer edge of the end girts (Fig. 2.7). The position of the mortises for brackets or drops indicate they originally extended beyond the end girts. Dow pieced these out with extensions to carry verge boards projecting about 6" beyond the clapboards. In piecing them out he cut off the outer few inches (probably to remove rot), so that only the inner 6"- 8" of the original remains. The joint line between the original girt and the added sections can clearly be seen in closeup photographs of the drops (Fig. 2.6).

2.7: 1913 photo of southwest gable corner showing old mortise for a drop or a bracket in the overhanging front plate, which has been cut back to install the 18th century rake boards flush to the facade of the attic gable. The presence or absence of a corresponding gain in corner post is the evidence needed to determine whether the original feature was a pendent drop as restored by Dow, or was a bracket as has been documented on Gleason house in Connecticut and the Indian House in Deerfield. Unfortunately there is no record of the appearance of the upper corner posts.

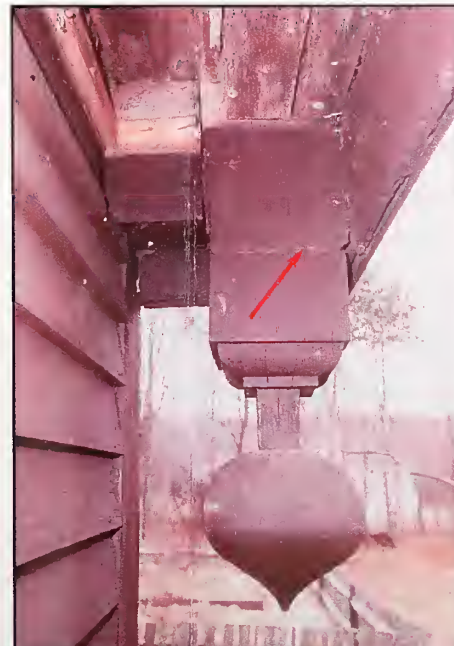
2.8: Existing pendent drop at the southeast corner of the front overhang. The extension of the original corner post to some 6" below the girt is clear in this photo (arrow marks joint to the restored drop)

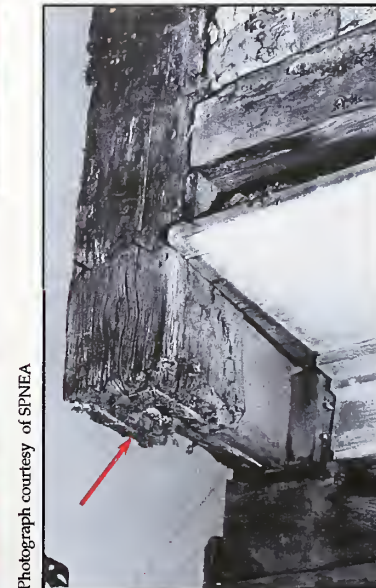
There is no firm evidence for the presence of these two drops such as was found at the Boardman House in Saugus (Fig. 2.9) because the ends of the overhang corner posts had been cut off long before Dow's restoration. There is a 1913 photograph of the southwesterly post end showing that it had been cut back flush to the bottom face of the end girt, exposing the girt tenon within the post (Fig. 2.10). There is no photograph of the southeasterly post end, but currently the original wood of the post extends only about 6" below the bottom of the end girt (Fig. 2.8). Appleton would likely have photographed it if there was any evidence in its remaining end. Millar states that the form of the restored drops was copied from the surviving original one at the Brown house in Wenham. Given that the southeasterly post extended more than 6" below the end girt, it seems likely it would have had some type of decorative termination. The restoration of the overhang corner drops at the Capen House is thus speculative but well based on period practice.

2.9: Photo of Boardman house corner post at the front overhang showing the type of clear evidence on the underside of the post for a pendent drop that is lacking at the Capen House due to the place the posts were cut off.

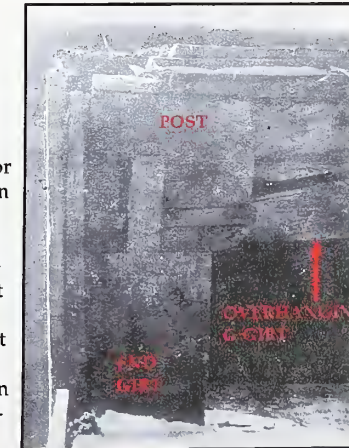
2.10: 1913 photo of underside of the southwest end girt/corner post joint showing that any possible evidence for a pendent drop had been previously cut off along with the bottom inch of the end girt. The surviving projection of the east end corner post below the girt (see 2.8) makes it highly improbable there was a bracket rather than either a drop or no ornament at this location.

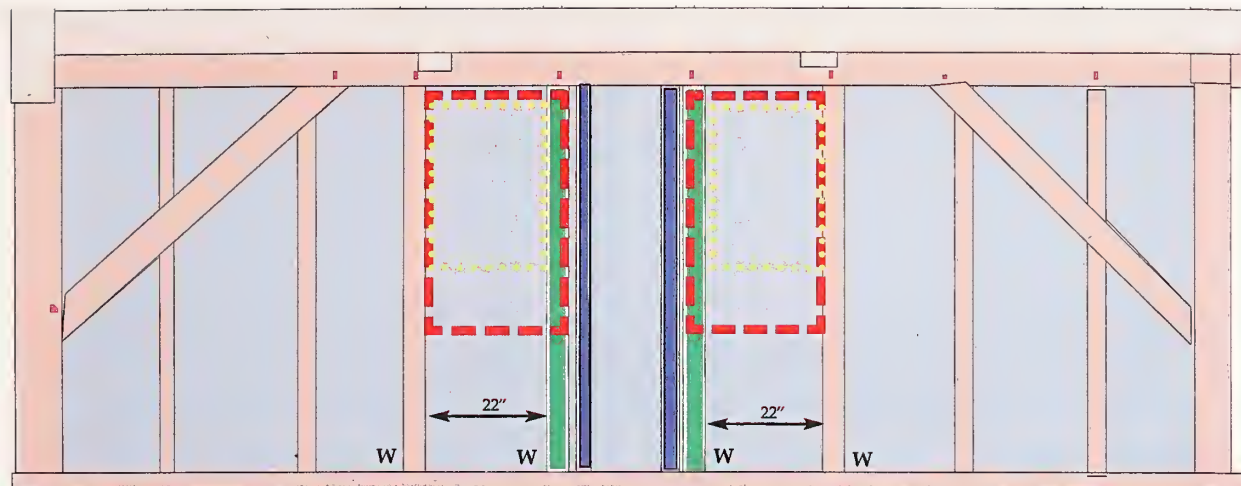
3.1: Elevation of parlor front wall framing. Original members are shown in light brown or green. Placement is based on existing pins in the front girt, which are shown in red, and the 1913 photographs with the framing exposed. The two original studs removed in the 18th century to enlarge the windows are shown in green, and the studs that were added to replace them at that time are blue. Oversize studs measuring approximately 4" x 4" that projected into the room beyond the finish plaster face are labeled "W" to designate they likely framed original windows. Evidence for the assumption that the two studs removed in the 18th century were of this type is provided in 3.3 and 3.7 below. All other original studs are approximately 3 1/2" wide by 3" deep and were presumably covered with plaster. The existing 1913 casement windows are shown in red and are a few inches shorter and about 1" narrower than the 19th century windows they replaced. The yellow dotted line indicates a conjectural placement of the original windows. Their width is based on the original stud positions, but no evidence was found for their height. The front wall framing of the parlor chamber and the hall and hall chamber is essentially the same as the parlor.

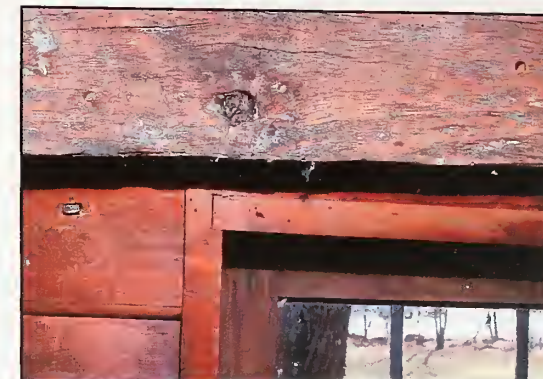
3.2: Closeup of window in 3.6 below showing relationship of the pin for the missing original window stud to Dow's window.

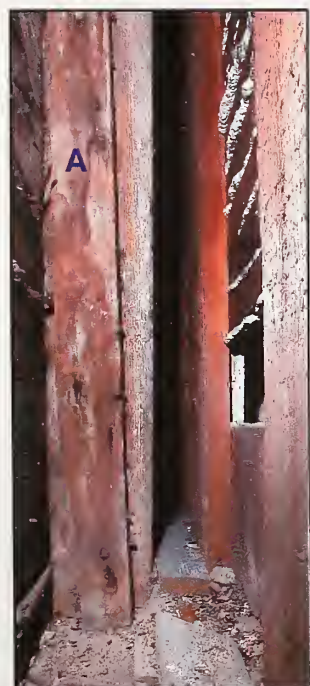
3.3: Existing 4" deep oversize window stud in hall chamber wall. Note that a furring strip (A) has been nailed to its side with wrought nails to receive plaster lath which were nailed to it with wrought nails. The 3" thick wall cavity was originally filled with brick and clay nogging (see 5.6). This stud had a notch cut into it about 3" below Dow's window like the existing parlor stud in 3.5. It also has cut nails in its face for an early 19th century plaster wall 4" deep. The current late 19th century wall is about 7" deep.

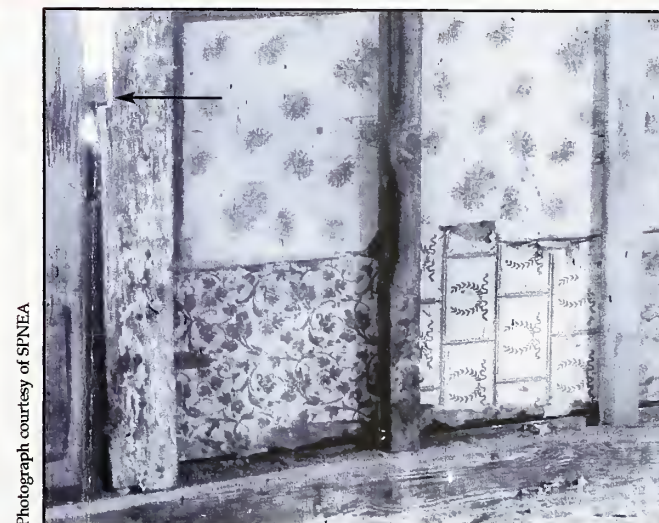
3.5: 1913 photo showing the right hand window stud after removal of the 19th century window frame. The notch marked by the arrow was cut to accommodate the width and height of the 18/19th century window, and removed the limited evidence we found in the west wall window stud (4.3).

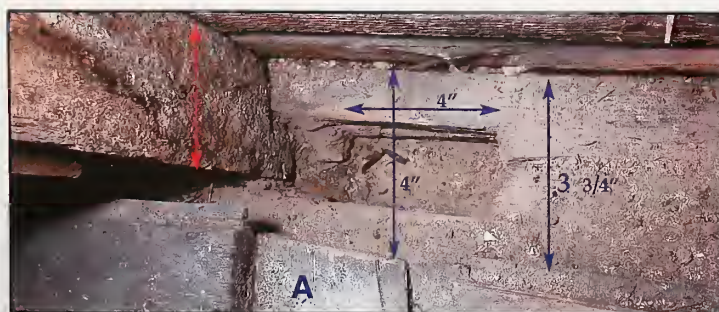
3.7: 4" wide Stud pocket in the overhanging front girt of the hall chamber for an original window stud that was enlarged to the left to accommodate the tenon for its 18th century replacement. the original floor board marked A is set back slightly from its neighbor making it just 4" from the sheathing. This and the 4" width of the mortise are the evidence that the stud was oversized.

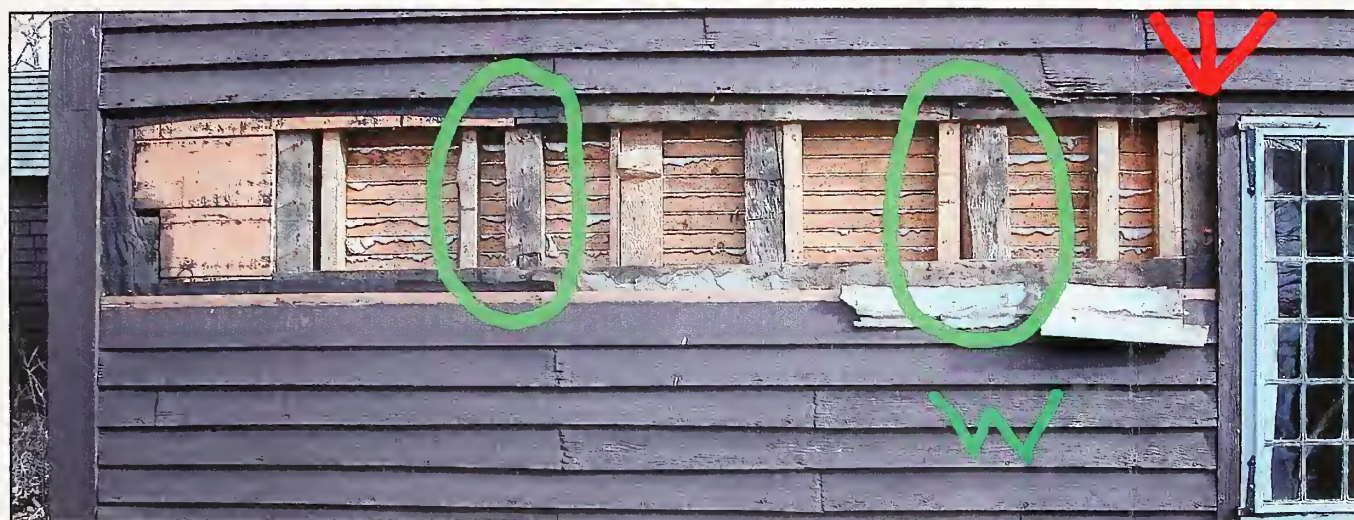
4.1: West first floor wall after removal of 18th century sheathing board showing early greyish colored studs with lath and light colored studs installed by Dow in the 1913 restoration. The early stud marked with the red arrow dates to the 18th century as explained in 4.4 and 4.5 below. The green "W" marks the original window stud shown in 4.3 below. The plain green circle marks the stud illustrating original clapboard evidence on Sheet 6 (see 6.1 and 6.2). The red push pins mark the position of holes from sheathing nails. Removal of one or two more sheathing boards to examine the lower portion of stud "W" is recommended to determine if there is similar evidence to the holes shown in 4.3 for a bottom pintle.

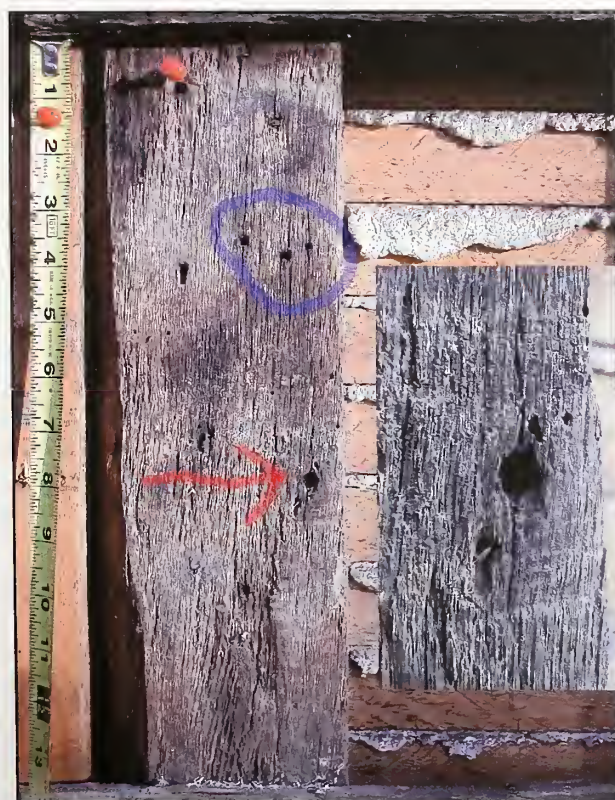
4.3: Original window stud at "W" in 4.1. Red arrow marks large hole possibly from a casement sash pintle (enlarged at right). Blue circle marks nail holes of unknown function, but possibly from a window header or trim. The red push pin marks the only nail coming through from the sheathing. The other unmarked holes are likely from the original clapboards. The notches cut in the front facade window studs would have removed any similar pintle evidence on those studs.

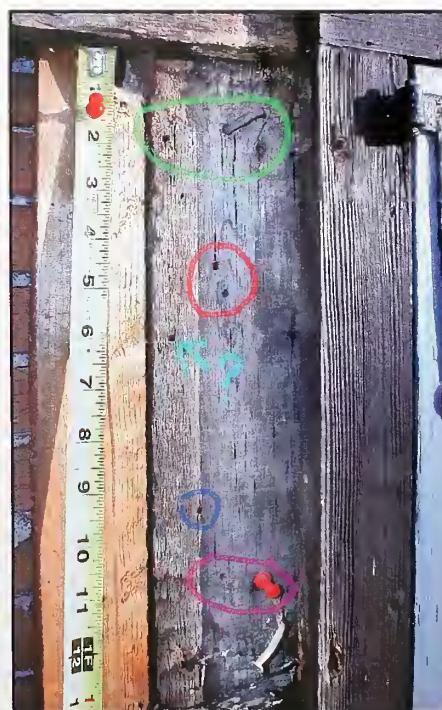
4.4: Stud added in 18th century with sheathing removed. Top of stud is secured in an open gain in the girt. All holes are from nails penetrating through the sheathing, in contrast to original studs that have clapboard nail holes not present in the sheathing.

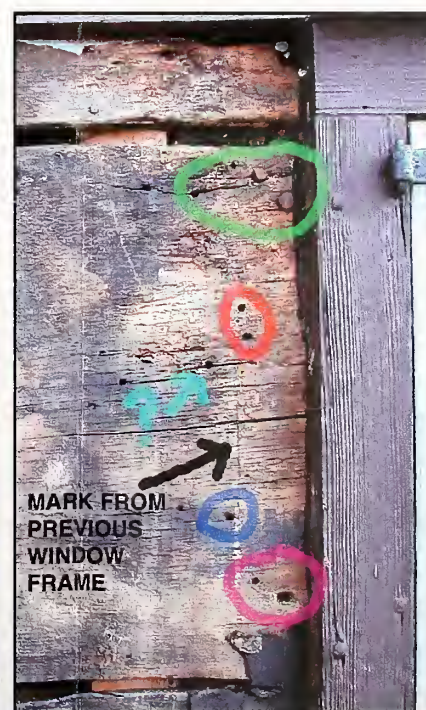
4.5: Sheathing board before removal from stud in 4.4. Matching color circles indicate alignment of nail holes in both photos. The large hole in the magenta circle was a wrought sheathing nail indicating the board was installed in the 18th century and was not removed by Dow.

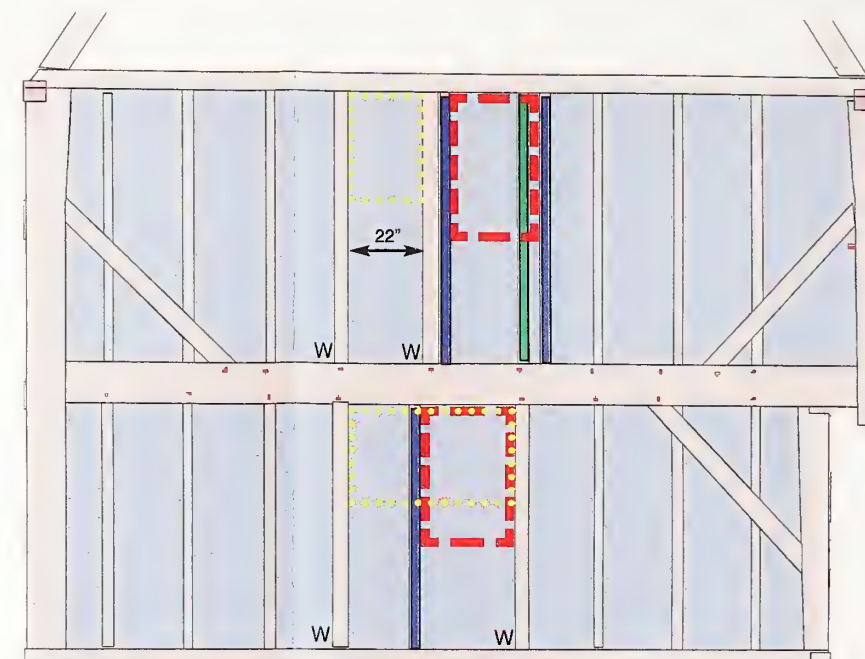
4.2: Elevation of west end wall framing. Original members are shown in light brown or green. Placement is based on existing pins in the girt and posts, which are shown in red. Original studs removed in the 18th century for window changes are green, and the studs that were added at that time are blue. Oversize studs measuring approximately 4" x 4" that originally projected into the room beyond the finish plaster face are labeled "W" to designate they likely framed original windows. Evidence for the assumption that studs that are now 3" deep were originally of this type is provided on east wall sheet #5 (5.7). All other original studs are approximately 3 1/2" wide by 3" deep and were presumably covered with plaster. The existing 1913 casement windows are shown in red and are a few inches shorter and about 1" narrower than the 19th century windows they replaced. The yellow dotted line indicates a conjectural placement of the original windows. Their width is based on the original stud positions, but no evidence was found for their height. The window stud positions on the second floor are based solely on the evidence found in the east wall.

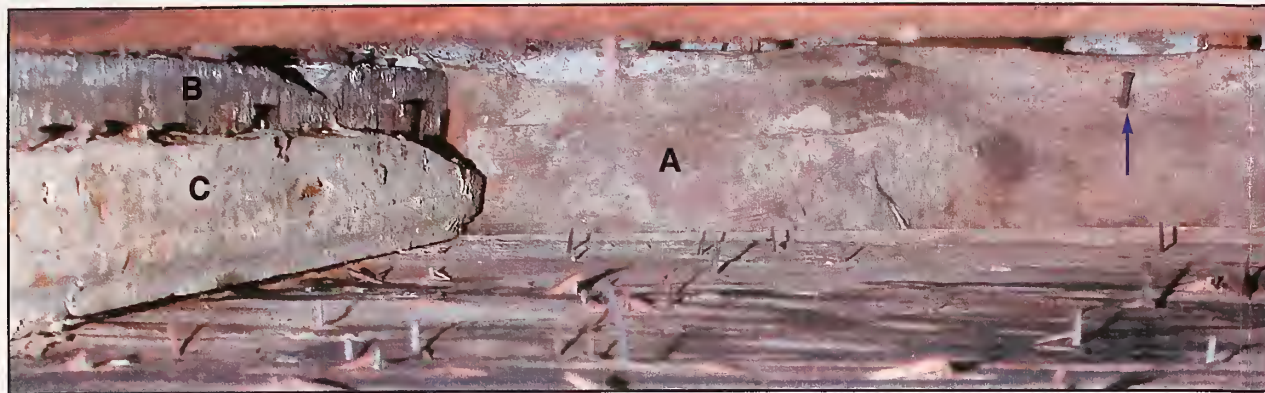
5.1: Location of original east end gable hall chamber window showing underside of attic girt (A) and the northerly window stud (B, W1 in 5.2). The evidence that this was originally a window bay is that the flanking studs are both 4" deep (see 5.4 below for the right hand stud) and that this bay was not originally plastered because the furring strip on the stud that received the lath and plaster is a reused piece of molded trim (C). The use wrought nails for the lath on the furring strip confirms the window was removed before c.1800. The function of the single nail in the girt (arrow) and the possibly related adjacent wear marks is not known. It is well left of the center of the bay.

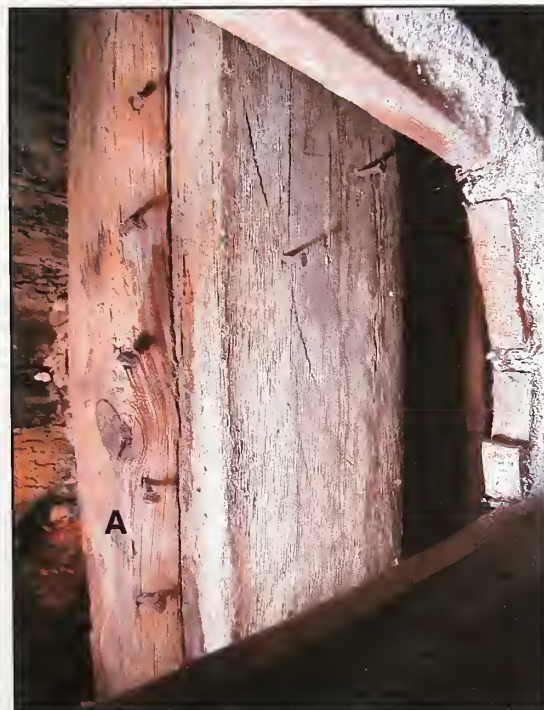
5.4: 4" deep right hand (southerly) stud (W2 in 5.2) of original east end gable hall chamber window at baseboard level showing furring strip for original plaster with wrought lath nails (A), and whitewash on surfaces that were originally exposed in the room. The cut nails in front the face of the stud relate to early 19th century renovations that moved the plaster outwards to completely cover the all the studs. Later 19th century lath and plaster of existing interior wall are at extreme right.

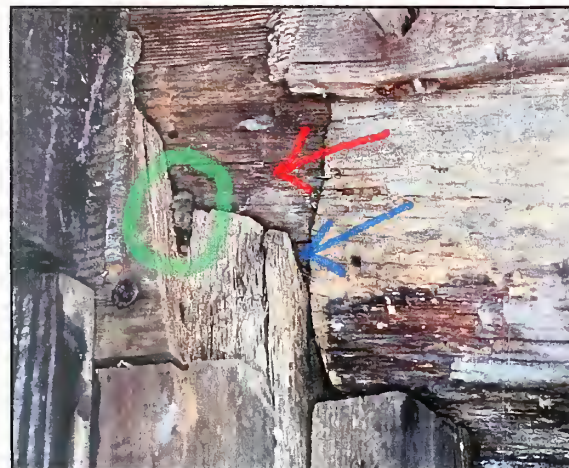
5.3: Top of door stud added in the 18th century (A in 5.5, #4 in 5.2). Tenon of stud (blue arrow) is fastened with a wrought nail (green circle) in a beveled gain (red arrow) cut into the outer face of the girt. Tenons of original studs are pinned in mortises cut in the underside of the girt.

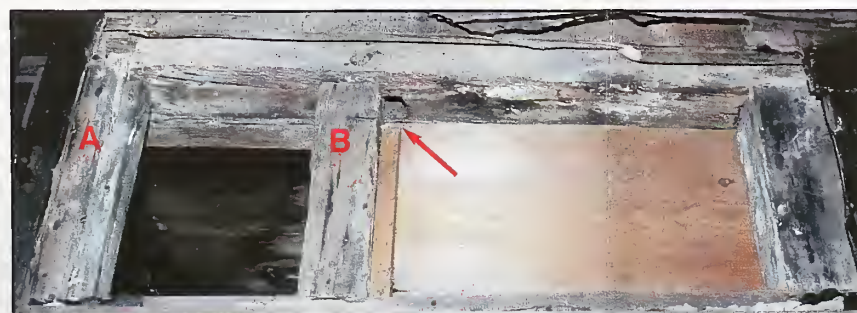
5.5: Exterior face of studs and girt to the north of the east facade door with sheathing removed. Stud "A" (4 in 5.2) was added in the 18th century to frame the new door. Stud "B" (W5 in 5.2) is the original window stud. Its mortise is 4" wide (arrow), although the stud is only 3" wide. Its interior face has been cut back to the 3" plaster line (see 5.7), making it similar to other original window studs except for its width. Its right side does not show any signs of having been cut down.

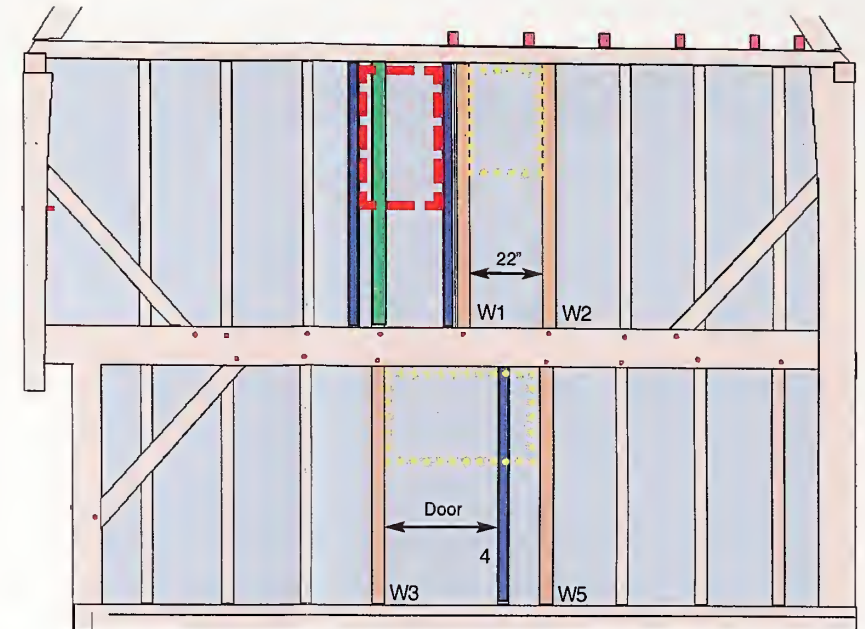
5.2: Elevation of east end wall framing. Original members are shown in light brown or green. Placement is based on existing pins in the girt and posts, which are shown in red. Original studs removed in the 18th century for window changes are shown in green, and the studs that were added at that time are blue. Oversize studs measuring approximately 4" x 4" that initially projected into the room beyond the finish plaster face are labeled "W" to designate they likely framed original windows. All other original studs are approximately 3 1/2" wide by 3" deep and were presumably covered with plaster. The existing 1913 casement windows are shown in red. The yellow dotted line indicates a conjectural placement of the original windows.

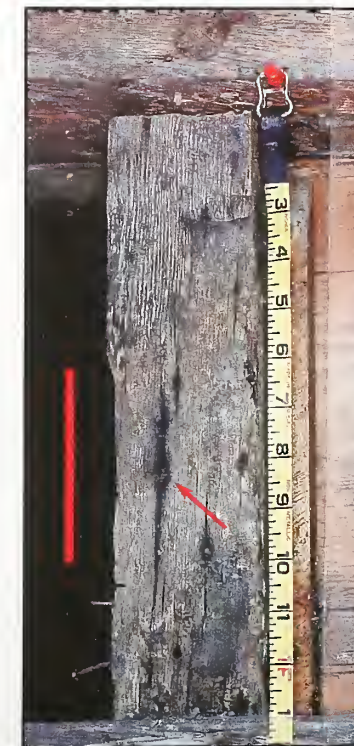
5.6: Window stud (B in 5.5, W5 in 5.2). The face of the stud is deeply eroded from about 6" down to 10" (Red line). Whether this erosion and the large nail holes (arrow) relate to the header of a casement window is highly speculative.

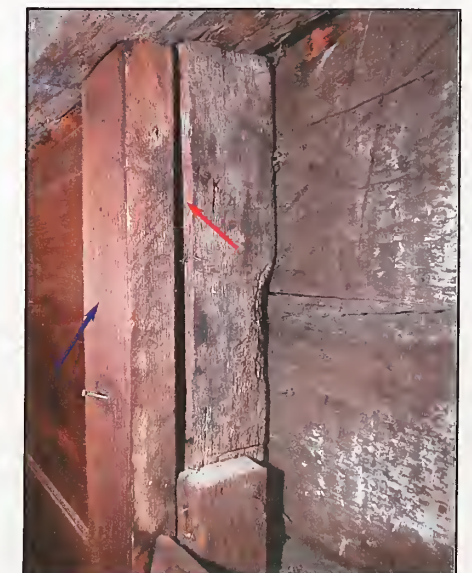
5.7: Window stud (B in 5.5) showing the fresher color of its interior face from being cut back to the 3" plaster line (red arrow), and new piece added by Dow to simulate its original depth (blue arrow). Also note erosion at front corner.

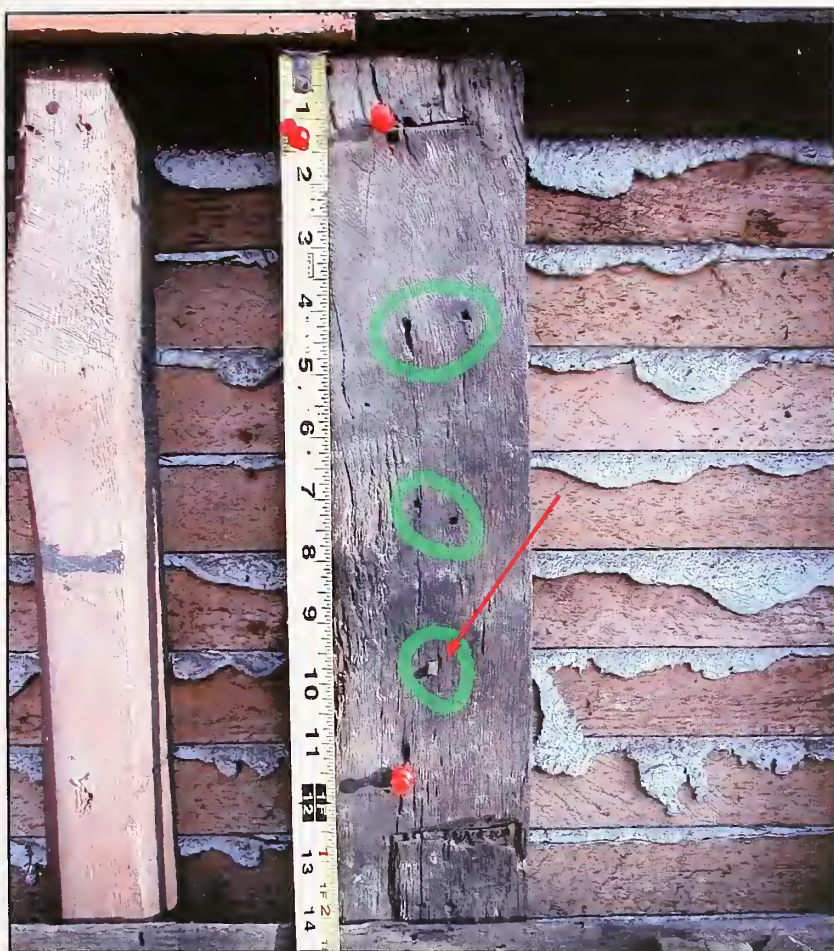
6.1: Evidence that original clapboards were installed directly on the studs revealed where 18th century sheathing was removed on west gable facade (see 4.1). Red pushpins mark nail holes that correspond to nails through the sheathing board. Green circles mark nail holes with no corresponding holes in the sheathing. Their vertical spacing is appropriate for clapboards. The circular saw marks on the relatively bright studs and lath installed by Dow are clearly visible.

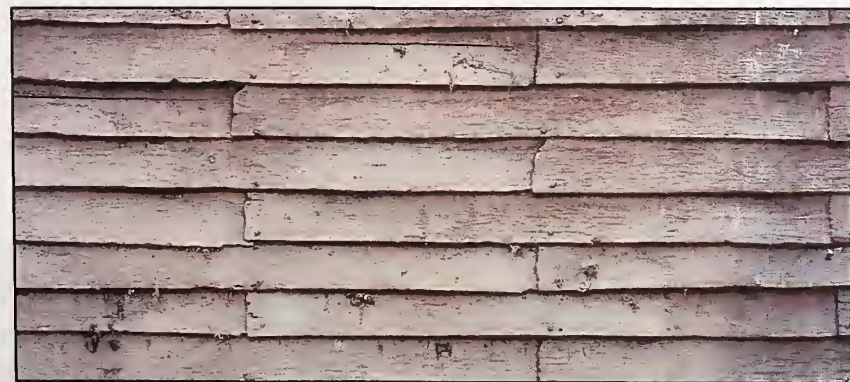
6.4: Regular nailing and layout pattern of original oak clapboards applied directly to the studs without sheathing at the late 17th century Bridges House in North Andover. Had Dow been rigorously following the evidence on the Capen house he would have applied the restoration clapboards in a similar manner. Note that in a few 17th century examples the clapboard joints are aligned in straight vertical rows to the studs rather than being staggered.

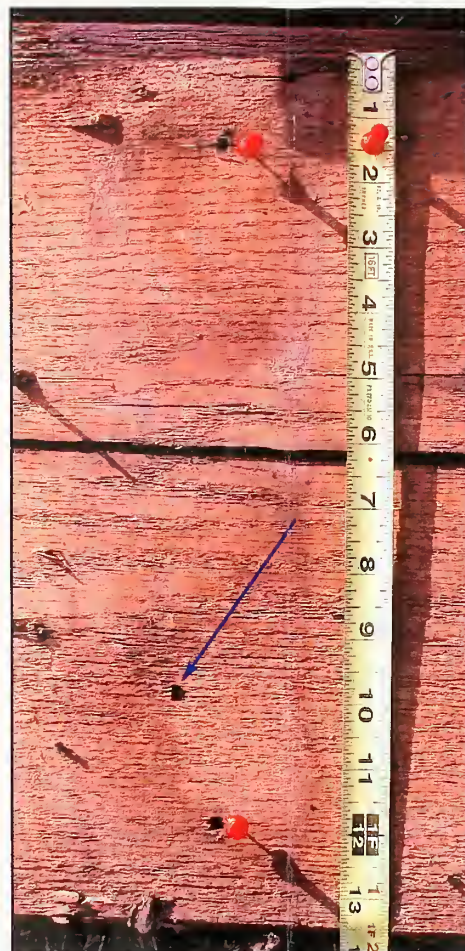
6.2: backside of 18th century sheathing board that aligned with the stud in 6.1. The red pushpins mark holes from the wrought nails that fastened the sheathing to the stud. The arrow points to a depression (not a hole clear through) from the broken off nail marked with a red arrow on the stud. The sheathing board is oak rather than pine. The shadow of the stud is clearly visible on the board.

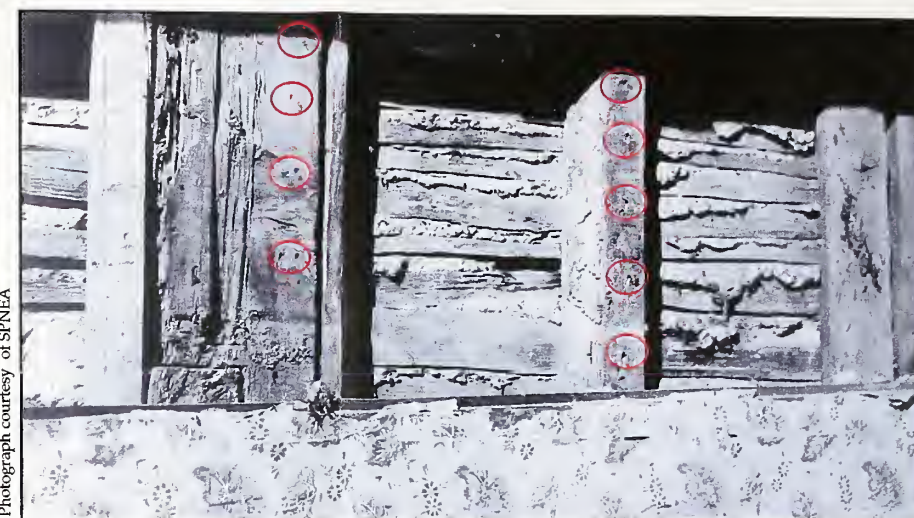
6.3: 1913 photo of easterly chimney post at the front facade. Regularly spaced holes (red circles) possibly from original clapboard nails are visible on the post and the first stud on the right. (based on pin evidence this is an original stud). Riven lath still remain in place on the studs. Their date is unknown but probably 18th century. The brick nogging has been removed. A reused interior partition board has been applied as sheathing. It is not known if these are still in place behind the clapboards.

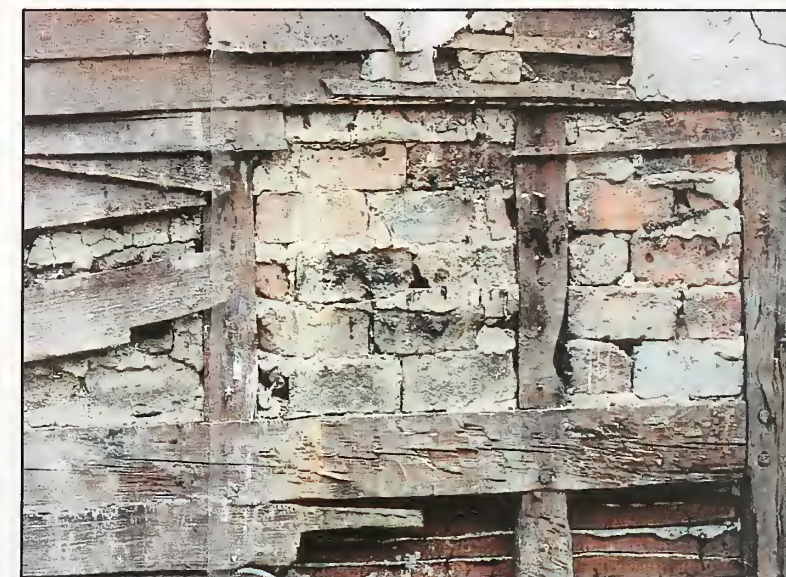
6.6: Photo of original brick and clay nogging still in place with oak clapboards applied directly to the studs at the late 17th century Bridges house in north Andover. The plaster lath in the lowest section is accordion lath applied in the early 19th century (probably the 1820's). The fragments of lath and plaster over the clapboards in the upper right are 18th century interior finishes applied after an addition was built in front of this wall in 1721.

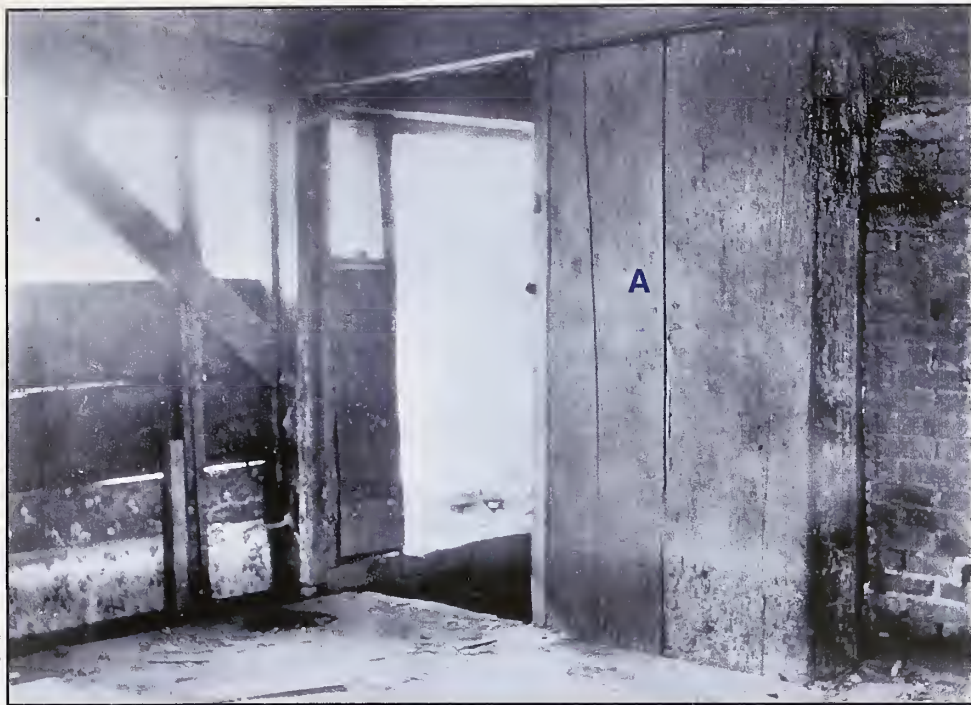
7.1: Southwest corner of Hall in 1913 after removal of later finishes and structural repairs. Appleton's note on the photo states that the vertical board sheathing marked "A" appears to be old but not original.

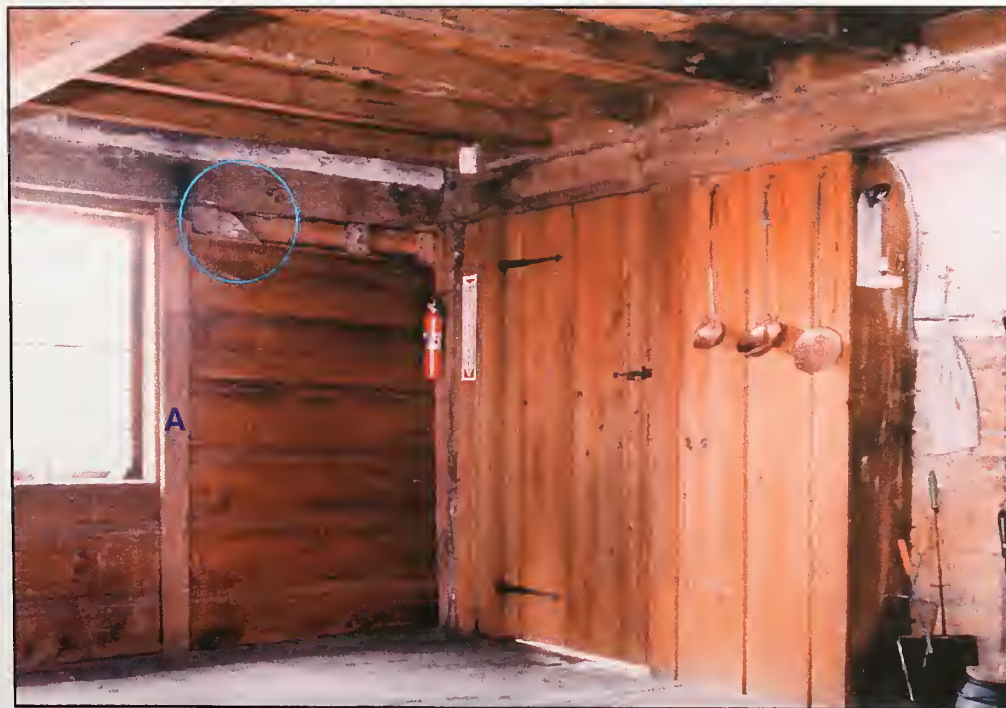
7.6 Southwest corner of Hall showing finishes installed by Dow. The feather edged vertical boards to the left of the fireplace replaced the old plain ones visible in 7.1. The plaster on the other walls was replaced with the same feather edged boards laid horizontally. The top board has been removed to expose the original framing that is also visible in the 1913 photo. The window stud (A) has been pieced out to match the ones in the parlor.

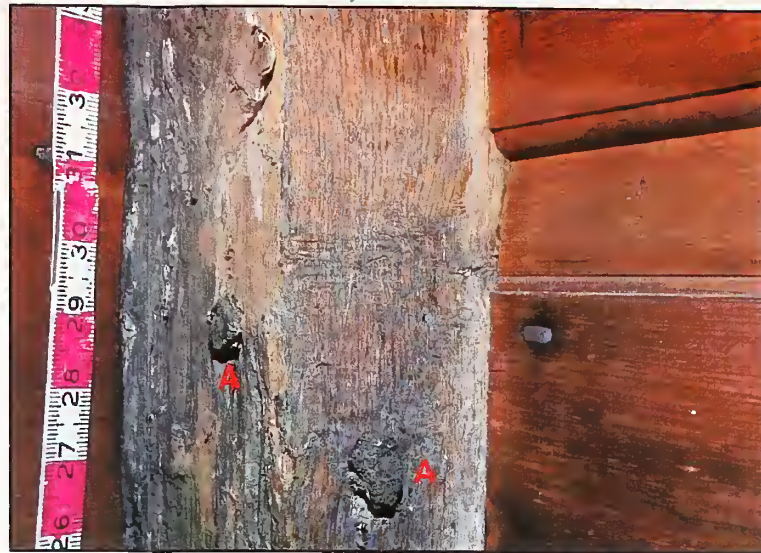
7.2: Southeast corner post showing detailing of the board sheathing installed by Dow as well as the T-headed cut nails used to install it. Remnants of 19th century oil paint and earlier whitewash survive on this post, which is largely obscured by the pewter cupboard. The pins marked "A" confirm there were braces on both sides of the corner

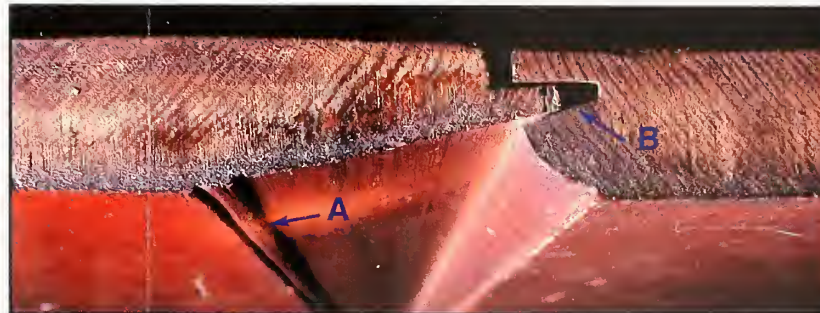
7.4: Cross section of feather edged sheathing used by Dow in hall, parlor, and stair hall. This general profile is characteristic of c. 1720's-70's sheathing rather than the 1680's. The small bead marked "A" is not usually present on this type of sheathing. The beveled shape of the groove (B) that receives the panel edge is a characteristic of modern joinery. In period work this would have been a simple rectangular groove formed with a standard plow plane. Dow had used identical sheathing in the Ward House restoration two years before with the same carpenter doing the woodwork using the same shaper blade to form the V groove.

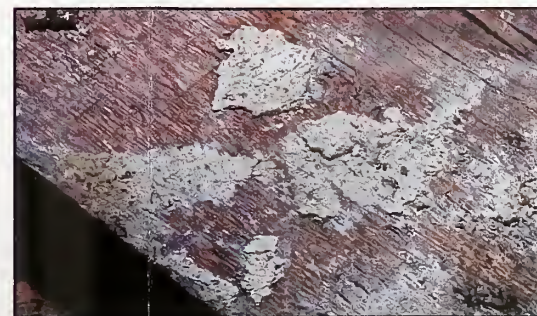
7.7: Remnants of clay on the interior face of the brace marked with a blue circle in 7.6 suggest the original room finish may have been clay plaster rather than board sheathing. Definitive conclusions regarding early finishes would require exposing considerably more of the original framing.

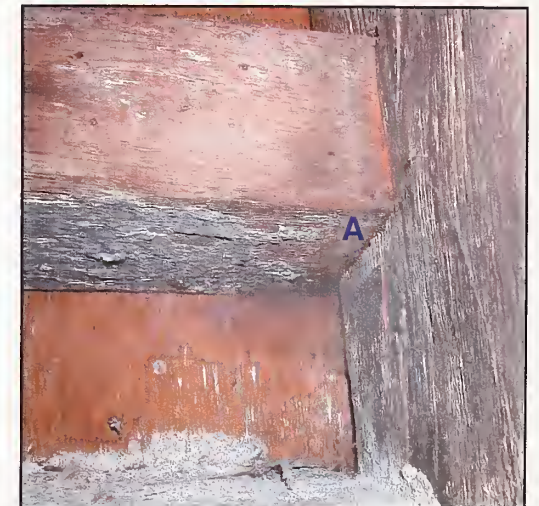
7.5: Remnants of early whitewash finish remain on the south side of the last ceiling joist where its proximity to the south girt makes it hard to see. The fairly uniform area about 1" wide without paint where the joist enters the summer beam (marked A) provides speculative evidence that an early partition extended to the ceiling along the summer beam (see sheet #10 for other partition evidence). The white area at the bottom of the photo is the plaster on the nogging above the girt.

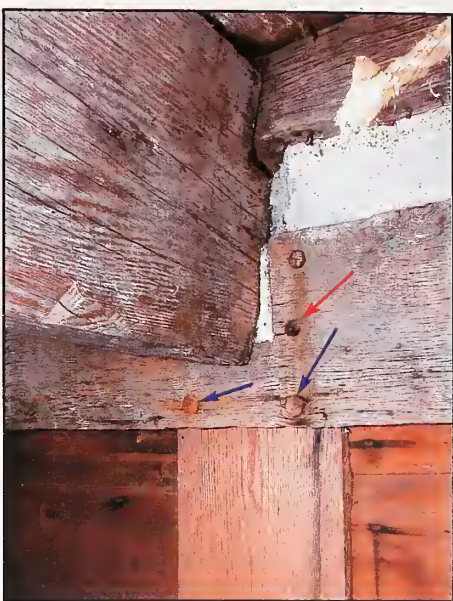
8.3: Detail of rear "post" under summer beam. Presumably Dow installed it based on the two pin holes above it (blue arrows) and the similar feature in the Parlor. The right pin hole is clearly old from the condition of the surrounding wood, but the age of the left one is not evident. The function and age of the empty hole to the right of the summer beam (red arrow) is unknown. The upper one is probably for a 2nd floor stud.

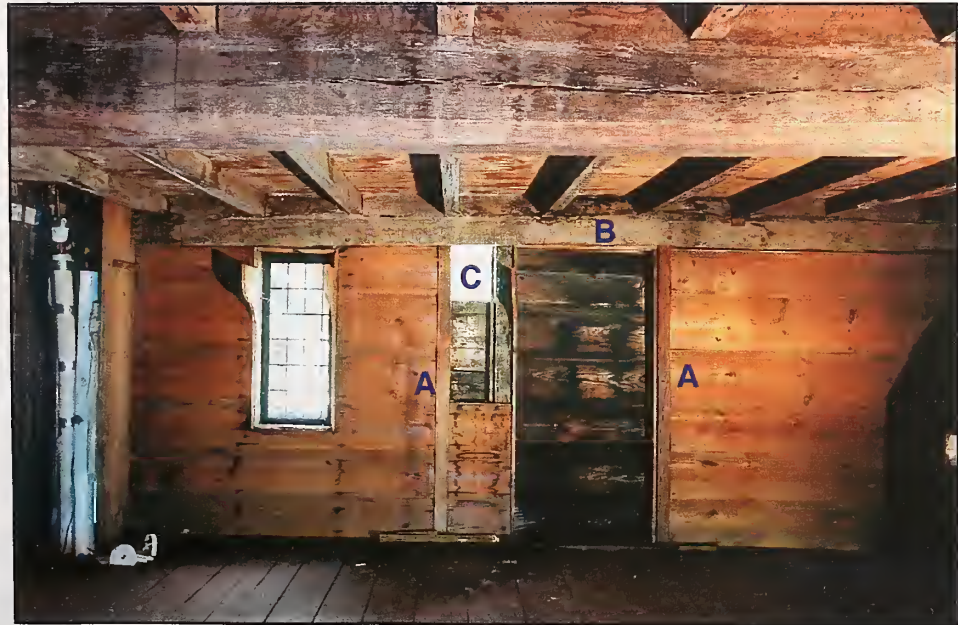
8.4: West wall. Studs marked "A" have been pieced out by Dow to extend into the room similar to the window studs in the Parlor. They likely were original window studs framing a two bay casement window. The door is a Dow reproduction in the location of a door added in the 18th century. "B" marks an area of old rot in the end girt repaired by Dow. The end girt slopes downward towards the rear wall due to 19th century deterioration of the sills. The wall sheathing at "C" was removed to examine the studs.

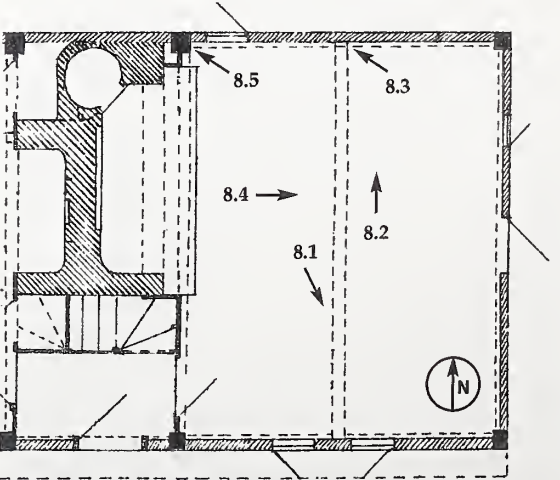
8.6 Plan of hall showing photo locations.

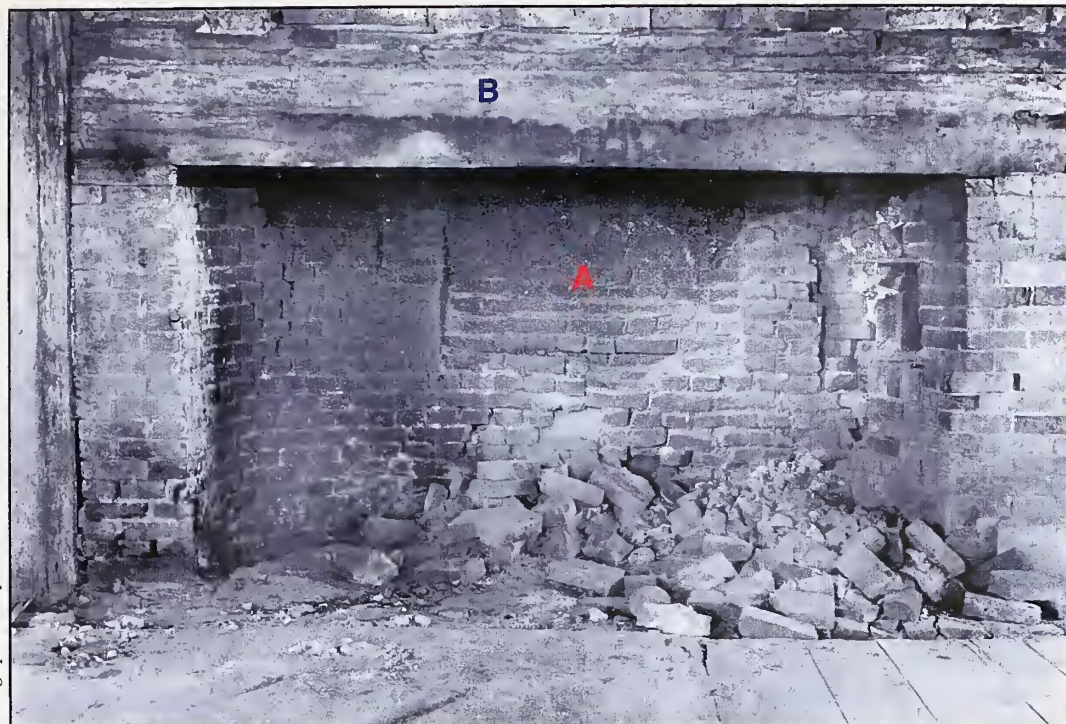
9.1: Hall fireplace in 1913 as revealed by removal of later infill material. Note rear inset panel (marked A), curved back corners, and coverboard over lintel (marked B). Appleton's notes on the photo stated the oven appeared to be of later construction (see 9.3).

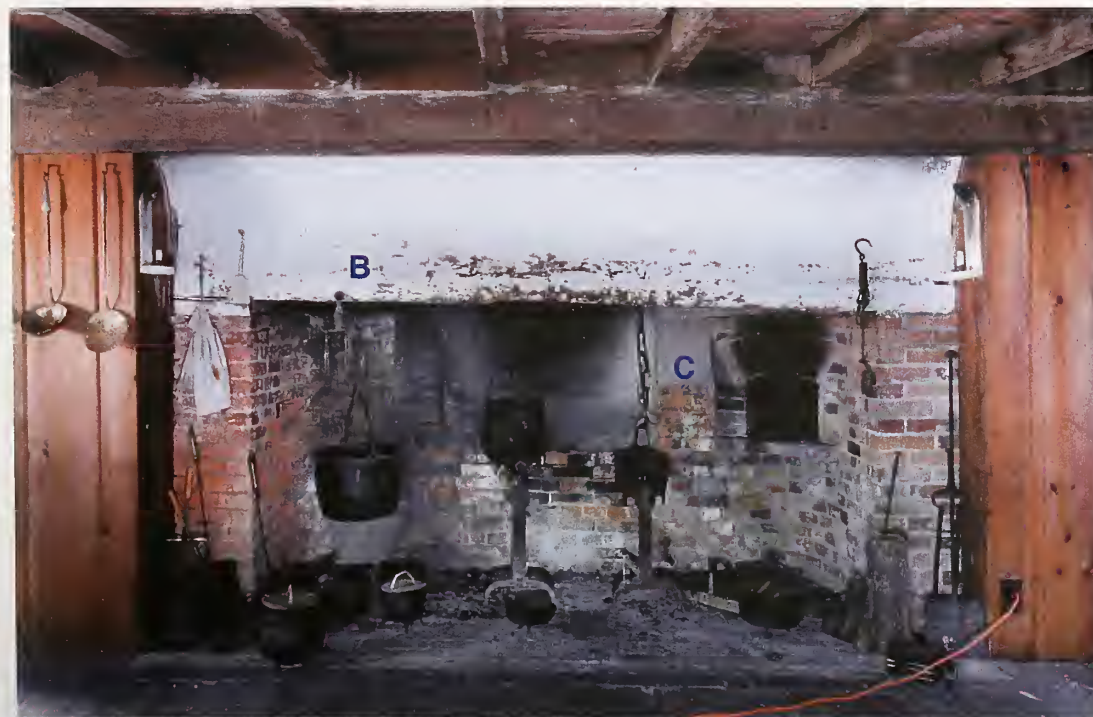
9.4: Current appearance of hall fireplace. The overall design with curved corners and inset rear panel is substantiated by the 1913 photo. The main left pier and left back corner, the small pier to the left of the oven (C), and the lintel coverboard (B) are largely original material with remaining traces of the original clay mortar. The right side is largely rebuilt. The application of grey cement parging to the inset panel and adjoining piers is recent.
